Manhole Inspection Summary

Manhole # **S17G__060MH**

Insp Date: **8/13/09 1:51 PM**

Location Address: **BEHIND 26 GORMAN AVE**

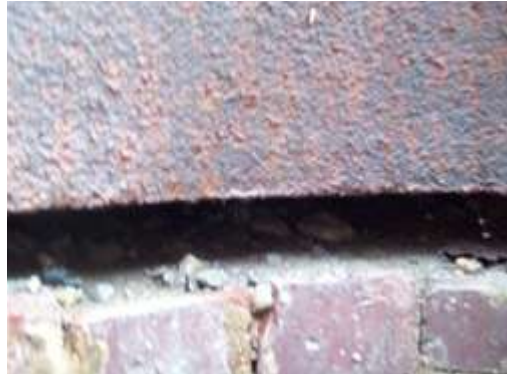
Defect 1

Condition: ☐ Sound ☐ Cracked ☐ Root Intrusion ☒ **Loose Brick** ☐ Deteriorated

LOOSE AND MISSING BRICKS ON
ADJUSTMENT

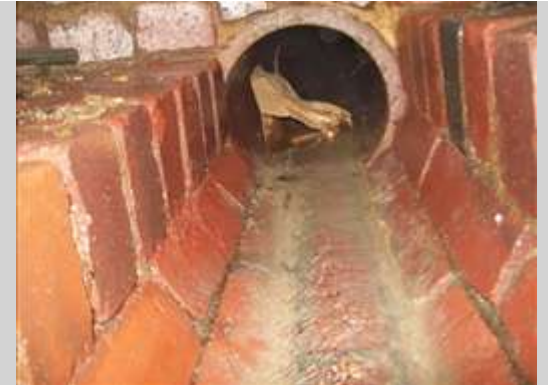
12 O'Clock Outflow

8 in. Circular Gravity Sewer
Pipe Out @ 12 O'Clock

Pipe Height: (in.) Direct
Pipe Material: **Clay** ☐ Pipe Lined
Invert Depth: **8.34** (ft.) Flow Characteristics: **Slow**
Deposits: ☒ None ☐ Mud ☐ Sludge ☐ Debris ☐ Grease
Silt Depth: (in.) Deposits Extent:
Infiltration: **None** Pipe Seal Cond: **Sound**

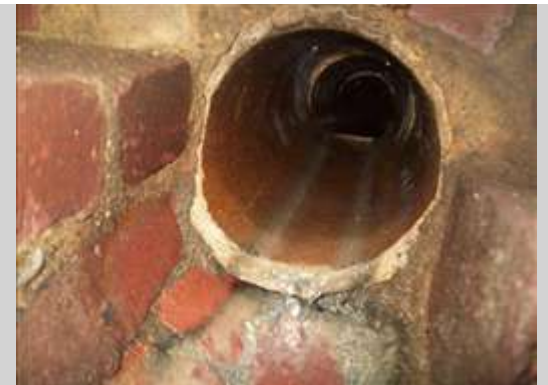
5 O'Clock Inflow

6 in. Circular Gravity Sewer
Pipe In @ 5 O'Clock

Pipe Height: (in.) Direct
Pipe Material: **Clay** ☐ Pipe Lined
Invert Depth: **8.22** (ft.) Flow Characteristics: **Slow**
Deposits: ☒ None ☐ Mud ☐ Sludge ☐ Debris ☐ Grease
Silt Depth: (in.) Deposits Extent:
Infiltration: **None** Pipe Seal Cond: **Sound**

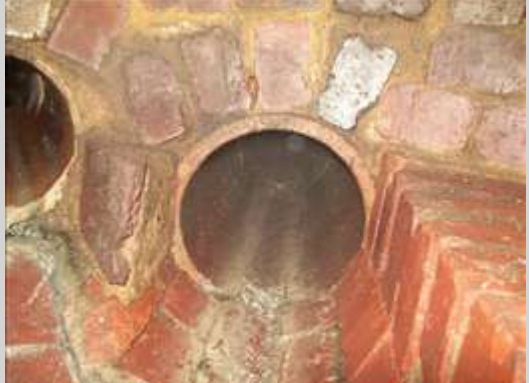
6 O'Clock Inflow

8 in. Circular Gravity Sewer

Pipe In @ 6 O'Clock

Invert Depth: **8.40** (ft.) Flow Characteristics: **Slow**

Infiltration: **None** Pipe Seal Cond: **Sound**
